# Pre Purchase Building And Pest Inspection

Inspection Date: 16 Mar 2025

Property Address: 6 Visor Street Manor Lakes 3024

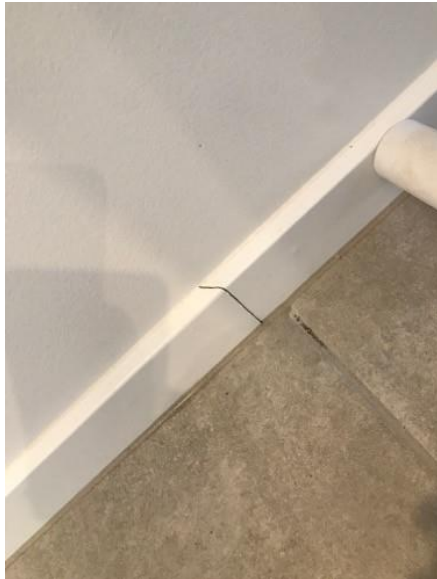
### Minor Defect 1.01

**Finding:** Skirting

The hallway wall presents a deficiency in the paint finish, notably in the form of a small crack above the baseboard. While the crack is currently minor, it should be monitored for any further development. Touch-up painting and possibly addressing underlying causes are recommended to maintain the aesthetic and structural integrity of the area.

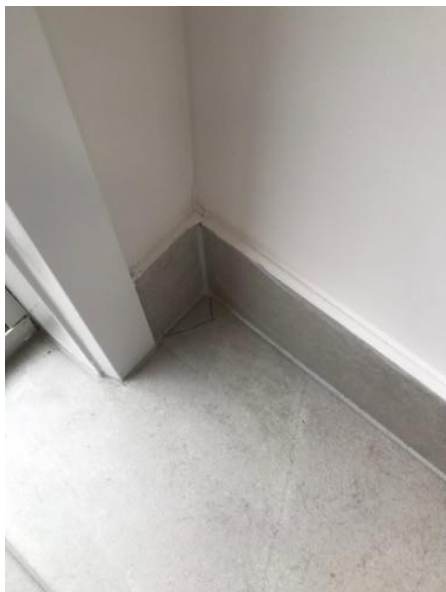
## Minor Defect 1.02

**Location:** Laundry

**Finding:** Tile

The laundry area of the property displays a noticeable crack where the wall meets the floor. This defect could potentially allow moisture ingress, which may lead to further issues such as mold or structural deterioration if not addressed promptly. It is recommended that this crack be assessed and repaired by a professional to prevent any future complications.

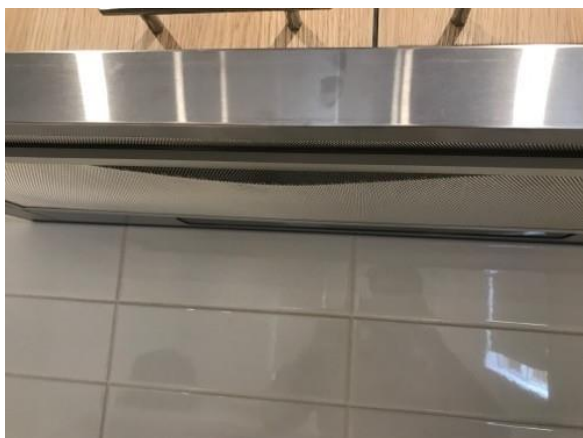
## Minor Defect 1.03

**Location:** Kitchen

**Finding:** Ranghood

The kitchen range hood has a notable defect, with the filter mesh partially dislodged from its housing. This issue may affect the appliance's functionality by reducing its ability to effectively filter air and remove cooking odors. Additionally, it might lead to further deterioration if not addressed promptly. Re-securing or replacing the filter mesh is recommended to restore the range hood to optimal working condition. Regular maintenance checks can prevent similar issues in the future.

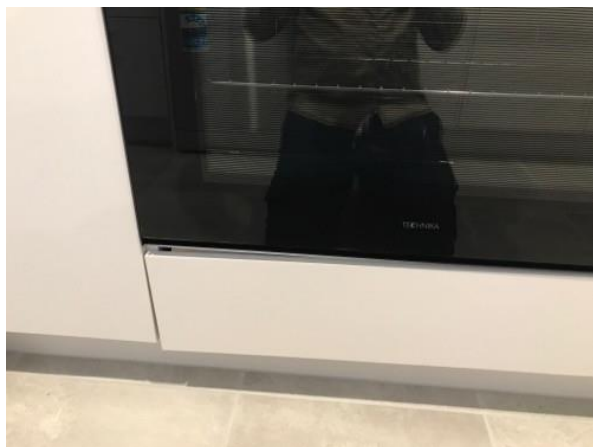
## Minor Defect 1.04

**Location:** Kitchen

**Finding:** Drawer

The kitchen presents a minor defect with damage to the lower drawer face located beneath the oven. The damage appears as a slight detachment on the left side, which may affect the drawer's functionality and aesthetic appeal. While currently not severe, addressing this issue promptly will prevent further wear and ensure the kitchen remains fully operational and visually pleasing.

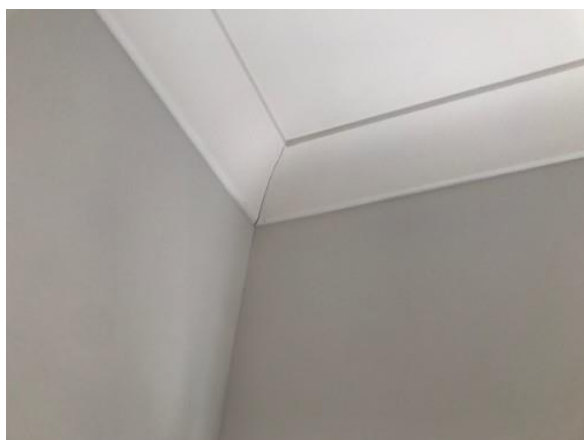
## Minor Defect 1.05

**Location:** Living area

**Finding:** Cornice

A crack is present in the living area's ceiling, located at the joint between the ceiling and the wall. While the crack does not currently seem to affect the structural integrity of the room, monitoring over time is recommended. If the crack widens or additional cracks appear, further assessment by a structural engineer may be necessary to determine if repairs are needed.

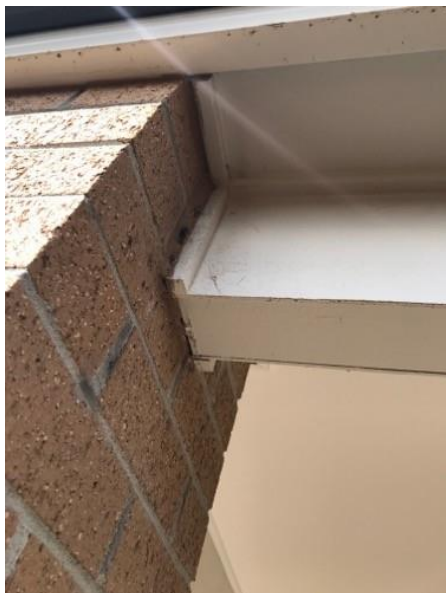
## Minor Defect 1.06

**Location:** Alfresco

**Finding:** Silicon

The alfresco area exhibits a defect where minor separation is visible between the brickwork and the adjoining beam. This gap may allow water ingress, potentially leading to moisture-related issues over time. The visible joint could also indicate insufficient sealing or structural movement. It is recommended to have this gap evaluated and properly sealed to prevent potential damage and maintain the integrity of the structure. Regular monitoring is advised to ensure no further separation occurs.

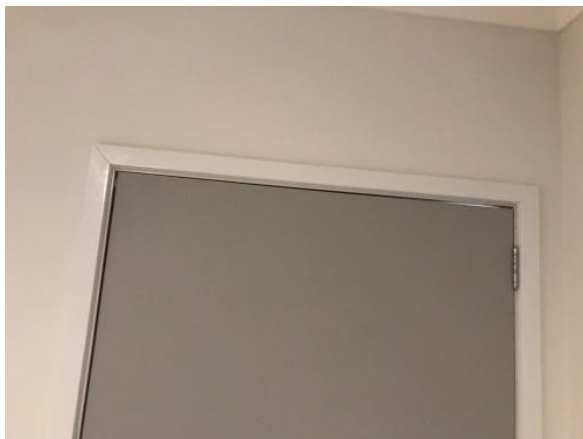
## Minor Defect 1.07

**Location:** Garage

**Finding:** External door

The garage door displays signs of alignment issues, as evidenced by jamming at the top. This defect likely results from improper installation or settling over time, causing the door to fit unevenly within its frame. The misalignment not only affects ease of operation but may also lead to further wear or potential damage if unaddressed. It is advisable to engage a qualified professional to assess and rectify the problem, ensuring smooth functionality.

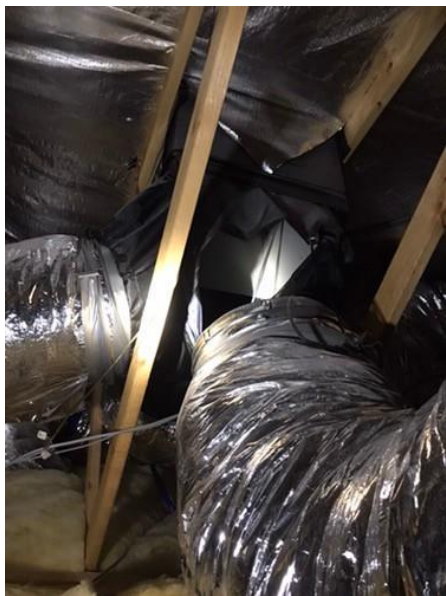
## Minor Defect 1.08

**Location:** Roofspace

**Finding:** Cooling system

The inspection of the roof space revealed a defect in the evaporation cooling system. The ductwork appears improperly secured, with visible disconnections and inadequate insulation, which can lead to reduced efficiency and potential energy loss. This situation requires correction to ensure optimal performance and to prevent further exacerbation of the issue. Repairing the ductwork and ensuring it is securely fastened and adequately insulated is recommended to maintain the system's effectiveness and to mitigate any future complications.

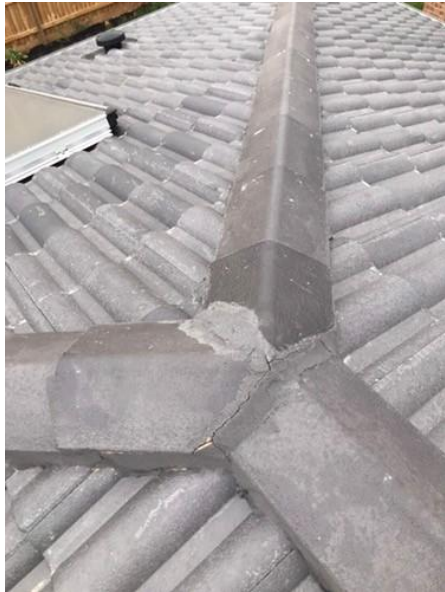
## Minor Defect 1.09

**Location:** Roof exterior

**Finding:** Ridge

The roof exterior displays a defect at the ridge capping where the mortar has deteriorated and cracked, compromising the seal between the tiles. This condition may lead to potential water ingress during heavy rain and further structural damage if not addressed. Immediate repair is recommended to restore integrity and prevent moisture-related issues within the property.

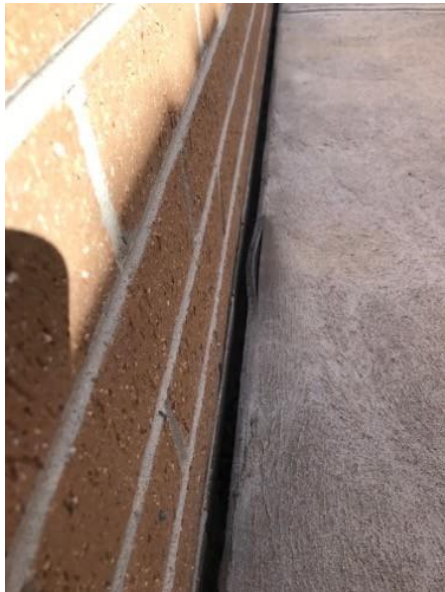
### Minor Defect 1.10

**Location:** All External Areas

**Finding:** Concrete path

The property exhibits a gap between the external brick wall and the adjacent concrete pathway. It's essential to monitor for any further shifts and consider consulting a structural engineer to assess the situation and recommend any necessary repairs or mitigations to prevent water ingress and other related issues.

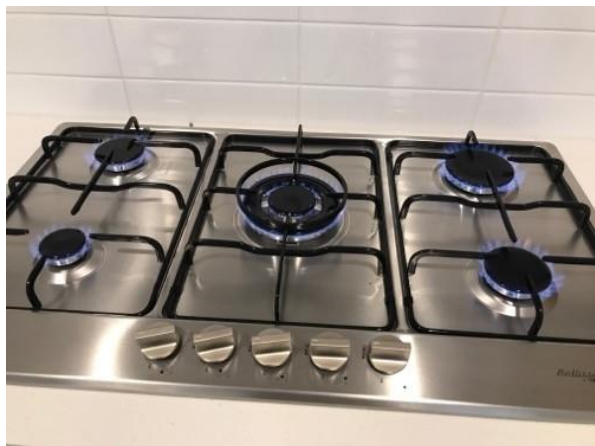
**Finding:** Cooktop

The kitchen stove shows no signs of working condition issues, with all burners functioning properly. The gas flame is steady and the ignition system operates effectively. No immediate defects were noted in regard to the stove's operational capabilities.

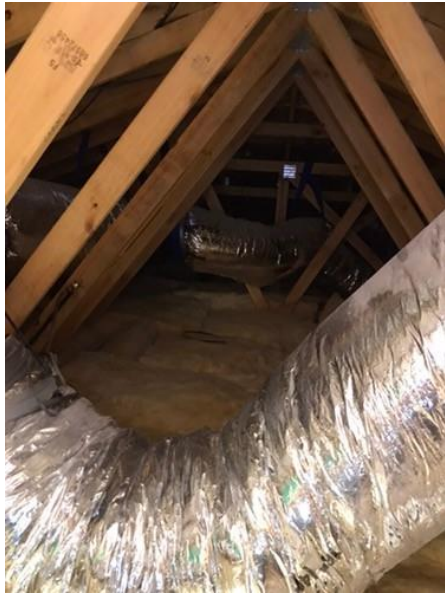
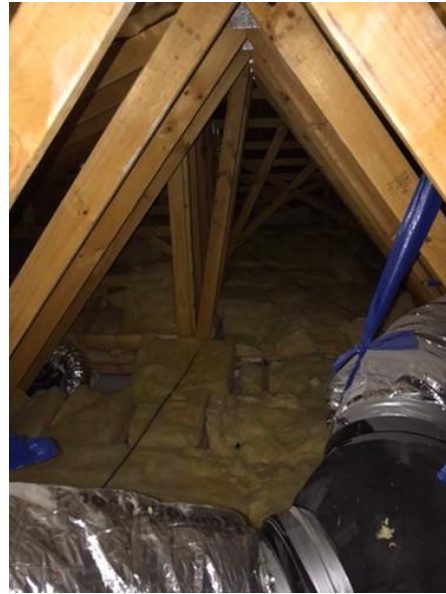
**Location:** Roofspace

**Finding:** Roof space  
Observation only

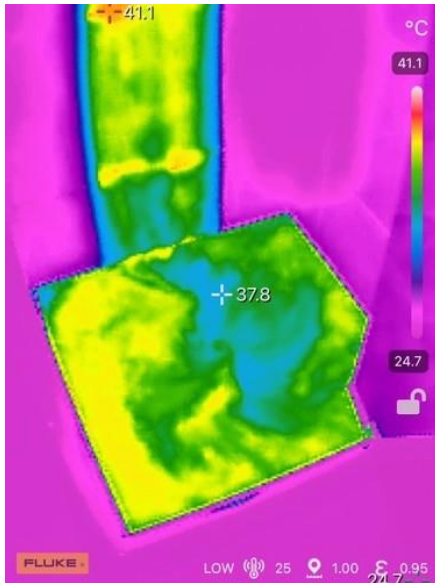
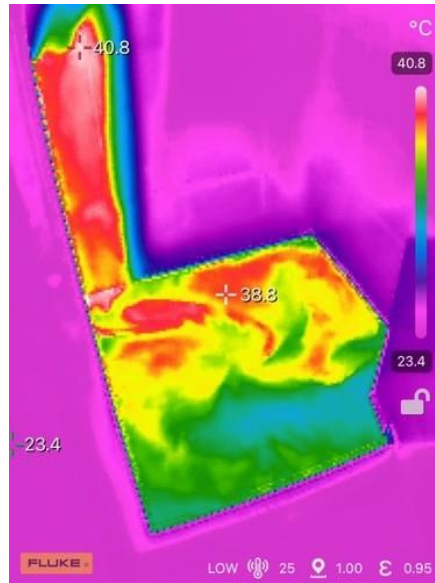
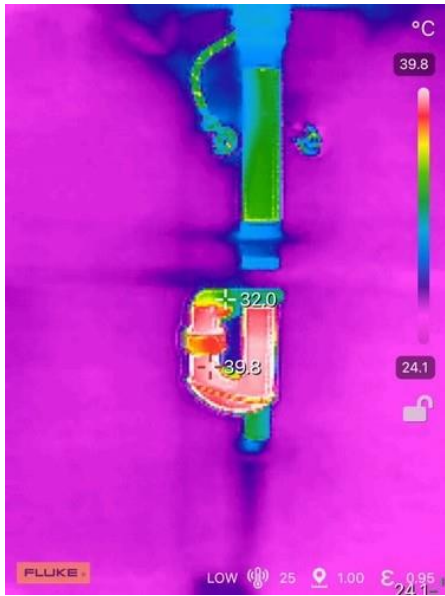
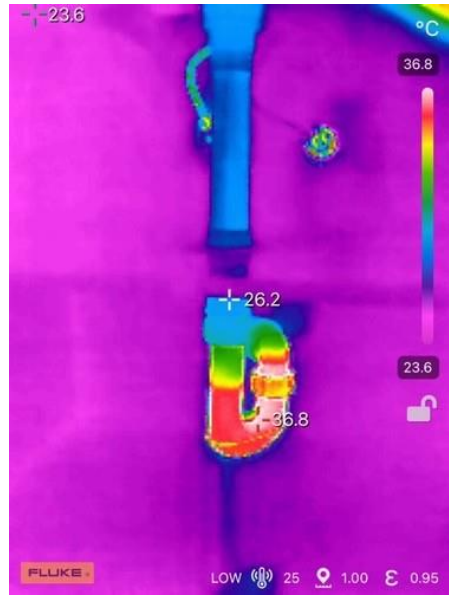
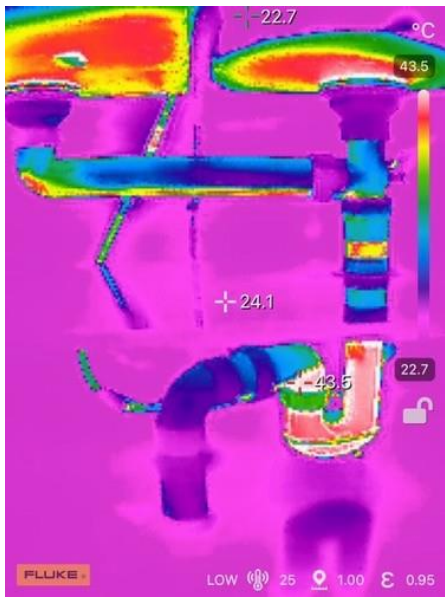
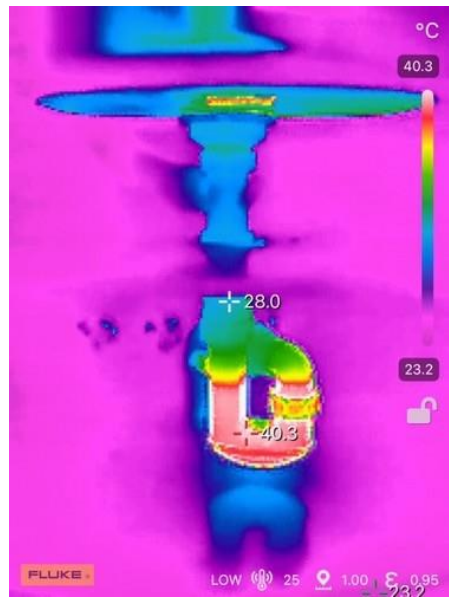
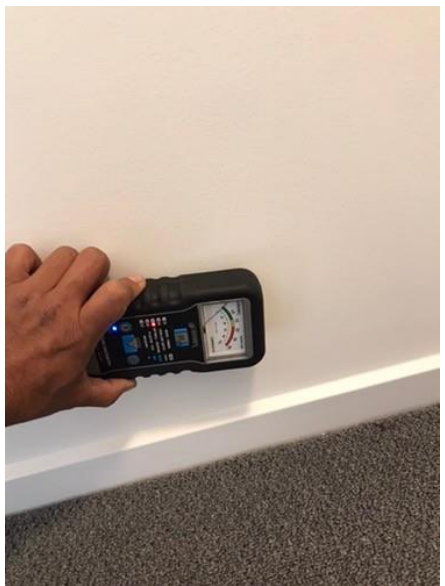
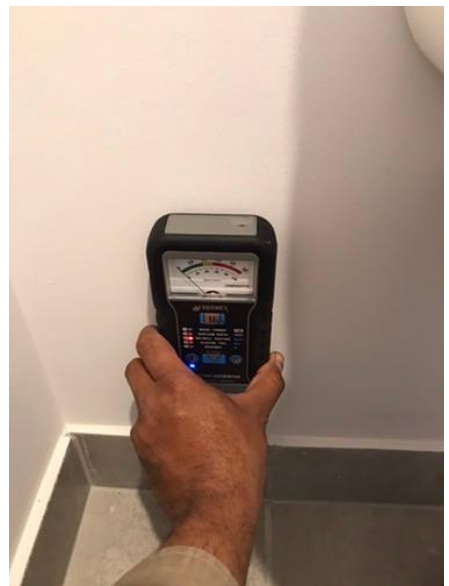
### For your information 2.04

**Location:** All Internal Areas

**Finding:** Water leak testing

The thermal imaging and moisture readings conducted throughout all internal areas of the property indicated no signs of water leakage. The images show consistent temperature readings, and moisture meters displayed results within the normal range, suggesting no current issues with leaks in the plumbing or related infrastructure. This assessment provides reassurance regarding the property's structural integrity concerning water intrusion. Further routine monitoring is recommended to maintain this state and ensure the early detection of any future issues.

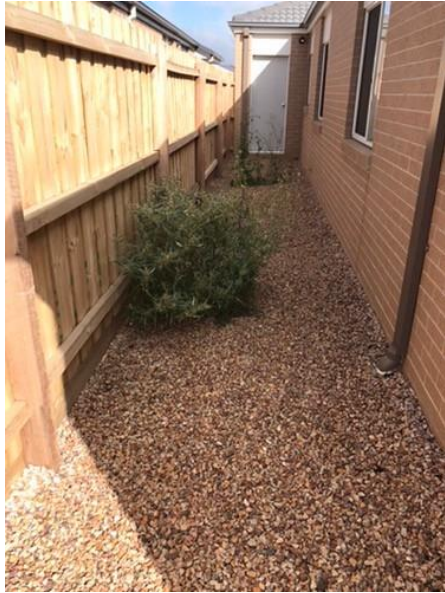
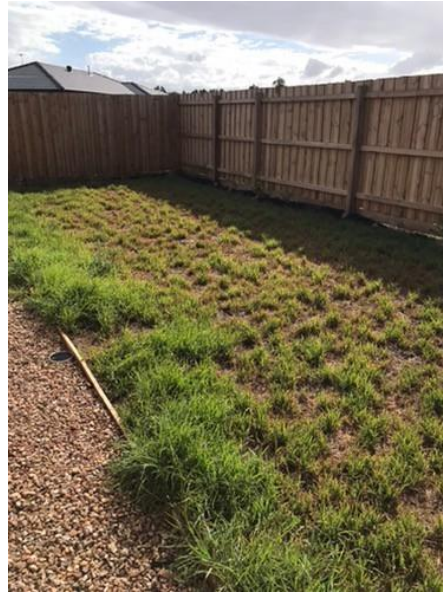
## For your information 2.05

**Location:** All External Areas

**Finding:** Vegetation

All external areas of the property exhibit significant overgrowth of weeds, particularly along the sides and back sections. The weeds are encroaching on the pebble paths and grass areas, which may affect the overall maintenance and appearance of the property. Immediate attention is required to address this issue to prevent potential damage to the landscape and to maintain a neat and orderly appearance. Regular upkeep is recommended to control the growth and spread of these weeds effectively.

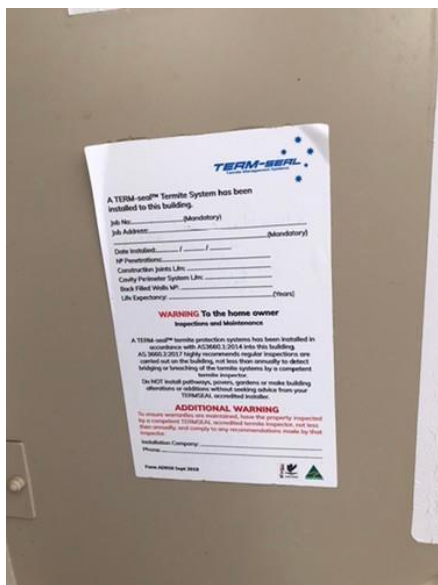
**Location:** All External Areas  
**Finding:** Termite system

The property displays evidence of a termite management system installed, but the information about installation is faded. However, regular inspections and maintenance are critical to ensure effectiveness, as per the warning highlighted on the system notice. It advises adherence to recommended inspection intervals to minimize risk of termite infestation. The report should include further evaluation for any potential breaches or wear in the system, as these could compromise its function. Consider arranging a professional inspection to confirm the system's integrity and up-to-date compliance.
